On site corrosion survey of Ni-added high-performance weathering steel bridge

KEYWORDS: Weathering steel bridge, Corrosive environment, Exposure test

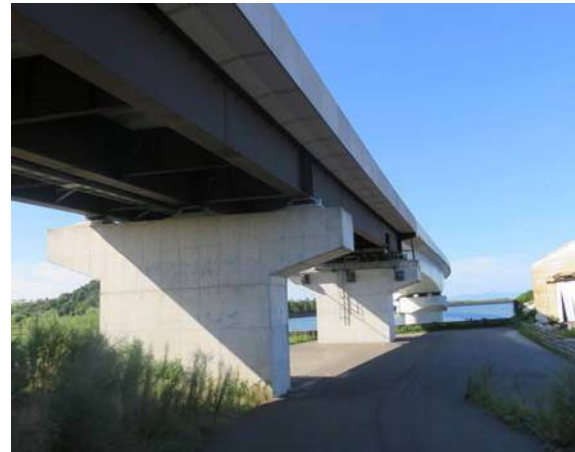
Figure 1 Otsuka viaduct

Weathering steel has a possibility of reducing maintenance cost, however, it is important to evaluate corrosive environment of constructed site in order to plan and maintain weathering steel bridges rationally. Otsuka viaduct is three-main girders plate girder bridge that was constructed within 200 meters from tidal river. Since a severe corrosive environment was anticipated, i.e. large amount of airborne salt, Ni-added high-performance weathering steel was used in the bridge. Therefore, exposure tests and measurements of amount of air-borne salt at the bridge was conducted in two years from March 2014, as a survey of corrosive environment and corrosion status.

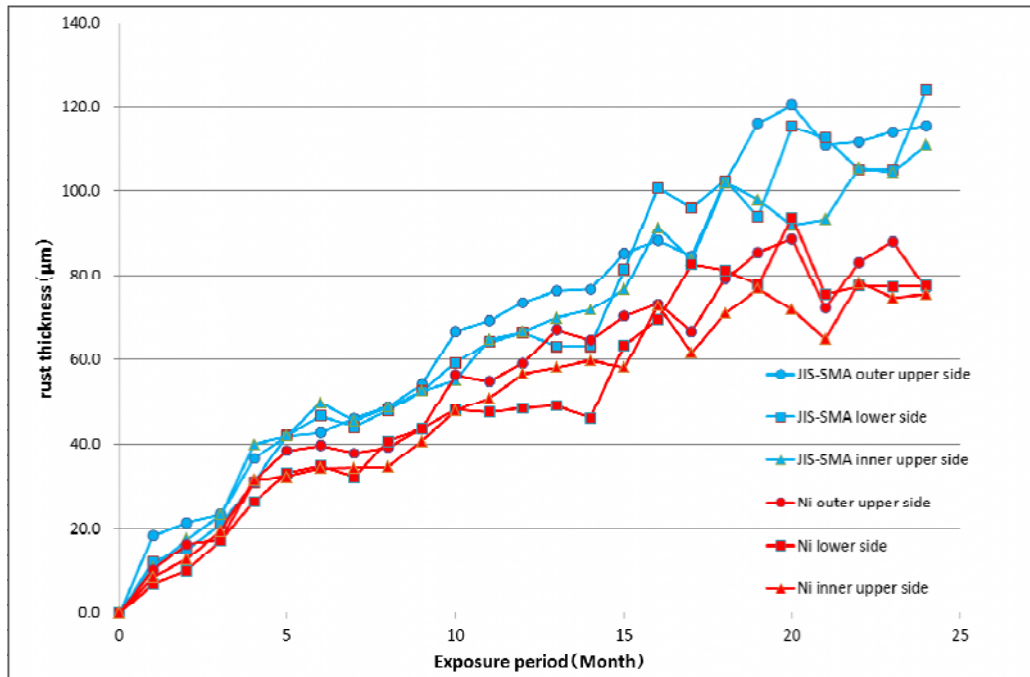
Figure 6 Growth of rust thickness on exposure specimens at bottom flange

Growth of rust thickness on exposure specimens at bottom flange are indicated in Fig.6. From the results of rust thickness, no significant difference was found in the corrosive environment between

outer side and inner side, but rust thickness of SMA was about 1.5 times larger than Ni-added high-performance weathering steel. Results of rust thickness show higher advantages of Ni-added high-performance weathering steel for weathering resistance than JIS-SMA.
